Soil nail remediation of seasonal slope movements in an old clay fill embankment dam

Andrew Lees, Geofem, Gavin MacDonald, Mouchel, and Andrew Sheerman-Chase, Cares Group

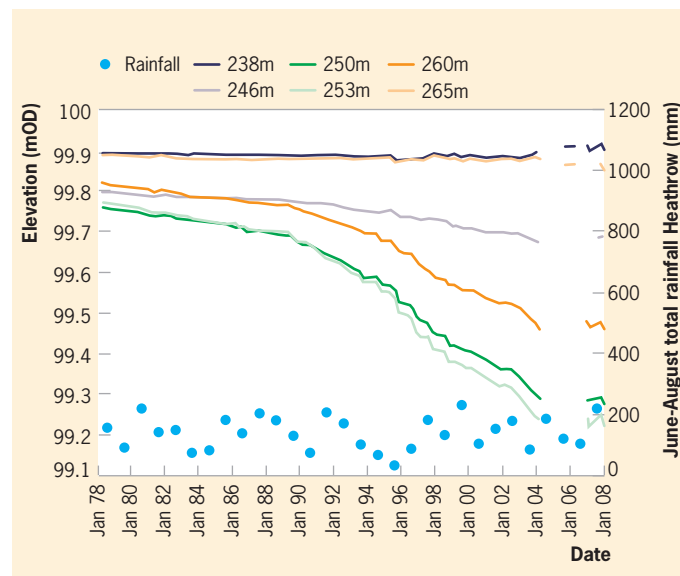
Figure 2: Wave wall settlement at unstable section

particularly unstable in the past 50 years. From about 1962, settlement of the wave wall at this point was reported. Wave wall levelling was undertaken in this area on a regular basis from 1978 onwards and its results are shown in Figure 2. Prior to 1988, average annual settlements between chainage 246m and 260m (the chainage is measured from the west shoulder) were about 5mm, but there were marked increases in the rate of settlement in 1989-90 (to 22mm/year) and 1995 (to 48mm/

As shown in Figure 2, while installation of the sheet pile wall successfully restored the freeboard, neither this nor the installation of the gravel drains in 1990 arrested the wave wall settlements. Only the installation of soil nailing in the upper downstream slope of the unstable section in October 2003 finally halted the settlements.

As shown in the displacement measurements at borehole A1/1 in Figure 6 as well as the wave wall settlement data in Figure 2, the soil nailing scheme was successful in halting the accumulation of downslope movements. This was also borne out by deflection measurements at other depths and in another borehole (refer to Lees et al (2013)).

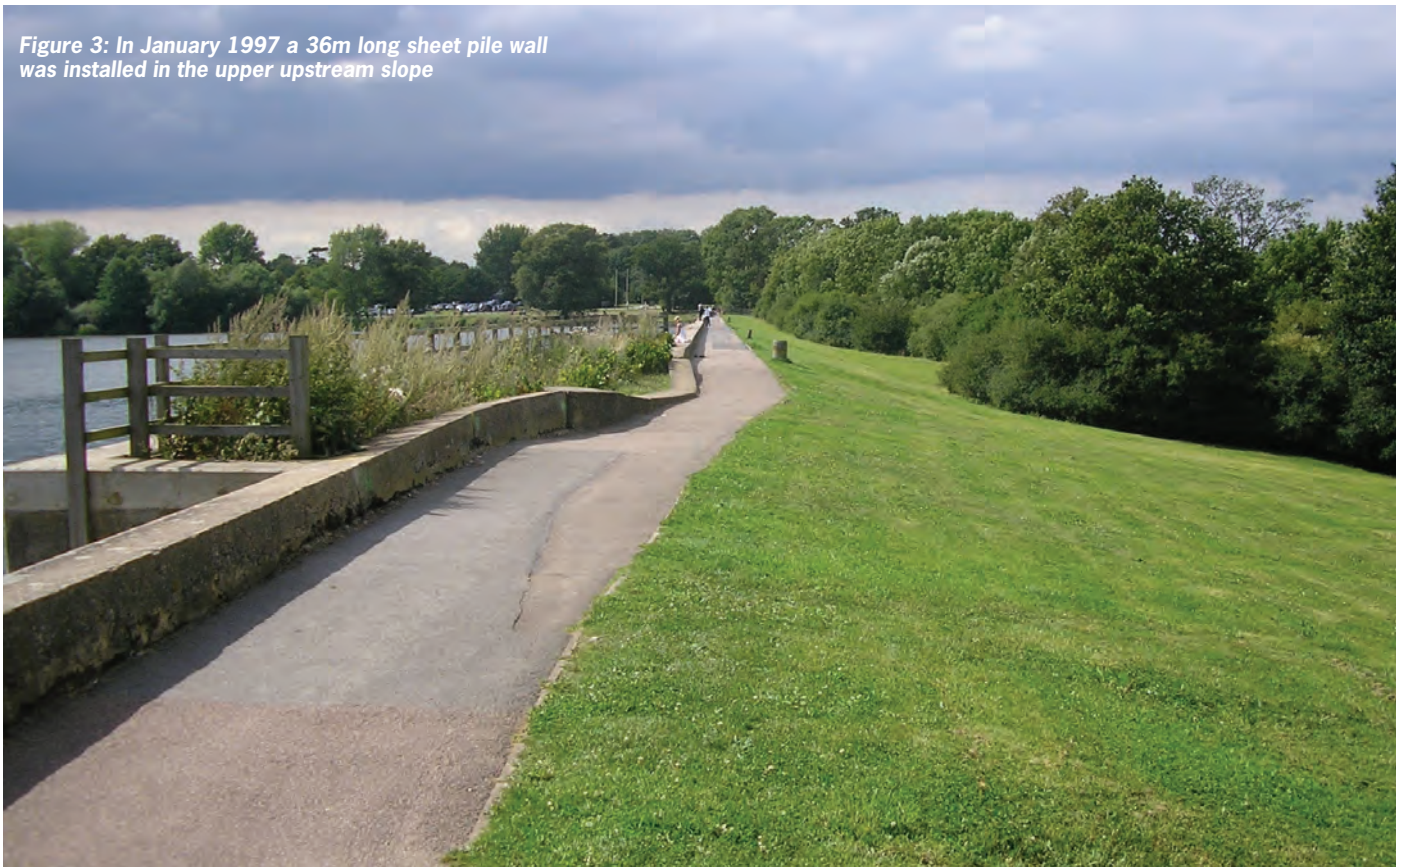
Figure 3: In January 1997 a 36m long sheet pile wall was installed in the upper upstream slope

In January 1997 a 36m long sheet pile wall was installed in the upper upstream slope around the unstable section to address the risk of loss of freeboard here due to the wave wall settlements, as shown in Figure 3. Earlier, in 1990, 2m deep gravel-filled drainage trenches at 5m centres were installed in the upper downstream slope of the whole dam to mitigate general deformations occurring in the crest footpath.

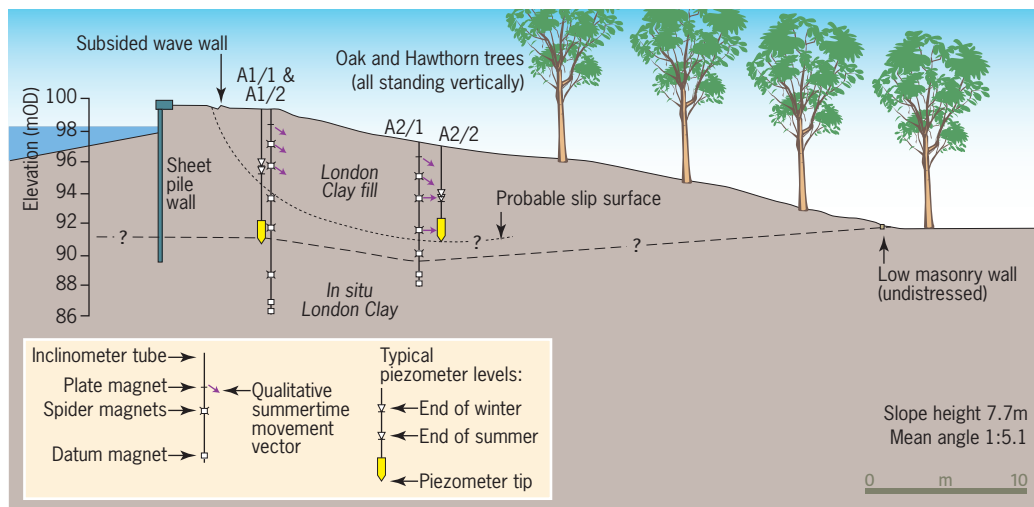
Figure 4: Cross-section of unstable downstream slope

Since 1974 to the present day, the upper slope has been grassed while only the lower slope has been covered by trees, as shown in the diagram of the unstable section in Figure 4. This resulted in a differential between upper and lower slope soil suctions that likely played a significant role in the initiation of a curious movement pattern at the unstable section.

Inclinometer A1/1 profiles for Summer 2003 with values reset to zero in April 2003 are shown in Figure 5. In spite of this being a particularly dry summer, it is clear that, remarkably, slippage occurred along a 5.5m deep plane. A 6m deep slip plane was also recorded in inclinometer A2/1 which, combined with the wave wall settlement, allowed the slip plane shown in Figure 4 to be drawn.

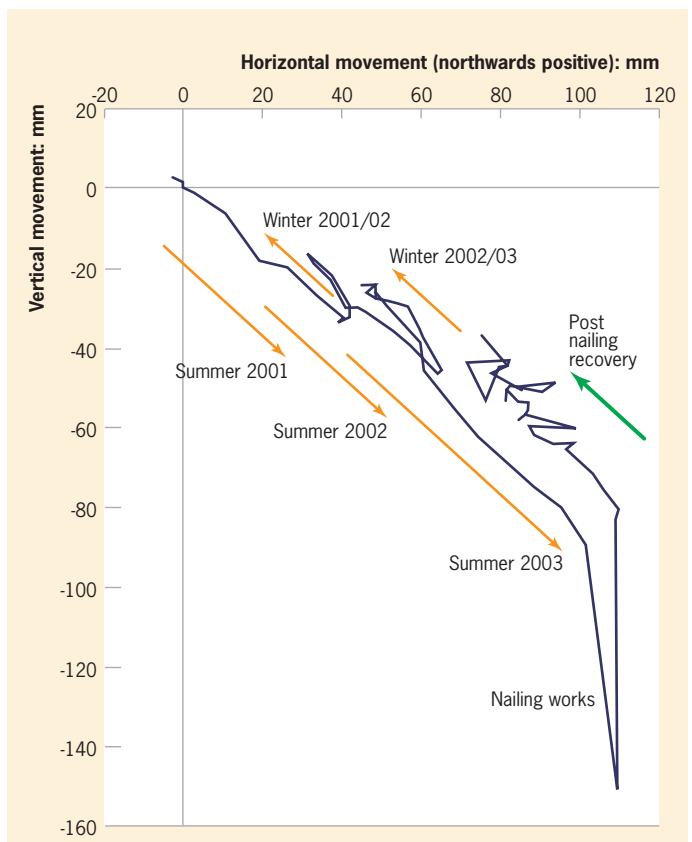
Figure 6: Measured deformations at 0.8 m depth in borehole A2/1 (April 2001 to March 2011)

The extensometer magnet elevation readings at 0.8m nominal depth have been combined with the horizontal deflection reading in the corresponding inclinometer A2/1 for the whole monitored period in Figure 6 to produce a vector plot of ground deformations at this point in the plane perpendicular to the dam. The overall approximate seasonal movements are indicated by the arrows.

There were cycles of downslope movement in each summer of 2001 to 2003, with by far the largest slippage occurring during the particularly dry summer of 2003, >>

« interspersed with partial recovery in approximately November to February each year. The A2/1 instrument suffered some disturbance, but no damage, during the nailing works and continued to provide data up to the last reading in March 2011. The plot shows that not only were downslope movements halted by the nailing but the low pre-stress imposed on the installed nails resulted in partial upslope recovery movements.

Indeed, the pre-stress in the installed nails resulted in an upslope recovery (Figure 6) of 35mm in the first year and a further 20mm in the following six years. No net annual downslope movement was recorded by any of the monitoring instruments in the 7.5 year monitoring period following nail installation.

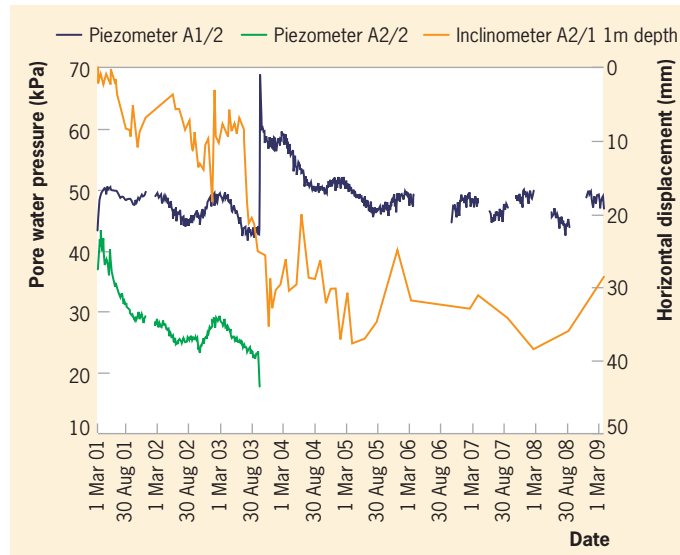
Figure 7: Piezometer data

The measurements from both piezometers are shown in Figure 7. A2/2 took longer to settle down, but both eventually recorded a small but regular approximate 5kPa seasonal variation reaching minima in late summer and maxima in spring. The lowest pore water pressure was recorded in the dry summer of 2003. A2/2 was damaged beyond repair during the nailing works but A1/2 continued to function and recorded about a 25kPa excess pore pressure due to the nail pre-stress that then dissipated over the following two years.

Also plotted on Figure 7 is a temporal plot of horizontal displacement recorded by inclinometer A2/1 at 1m depth. It confirms the paradox that significant downslope movements in the summer (prior to the nailing works in September 2003) coincided with reduced pore water pressure.
