# Soil Nailing: Application and Practice – part 2

by D.A. BRUCE<sup>††</sup>, BSc, PhD, CEng, MICE, MIWES, MASCE, MHKIE, FGS  
and R.A. JEWELL<sup>†</sup>, MA, PhD, CEng, MICE

THE INSITU GROUND REINFORCEMENT TECHNIQUE of soil nailing was introduced in Part 1 of the Paper and contrasted with other methods of ground reinforcement and stabilisation. The history and evolution of the technique were reviewed and the main applications described.

The aim of the second half of the Paper is to describe current good practice for soil nailing. Firstly, seven case histories are reviewed illustrating the range of applications for soil nailing and giving construction details. Tables summarising details from published case histories worldwide are presented. Then, on the basis

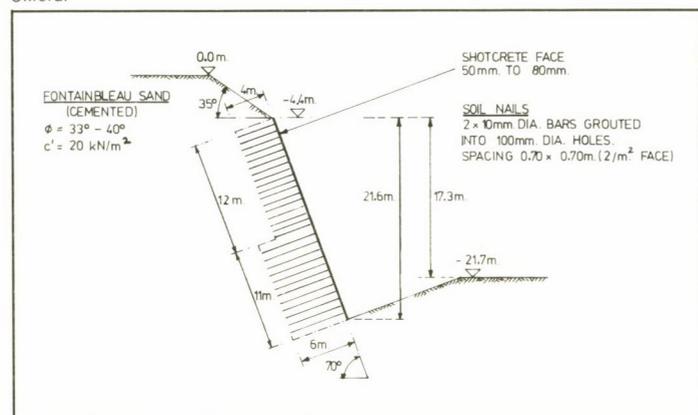
Fig. 18. Cross-section of the highest cut at the Versailles-Chantier excavation (After Toudic, 1975)

and the geometry of these cuts was dictated by a highway at the top of the slope (Fig. 18). A slope height of up to 22m was required at a 70° slope angle. The decision of the Engineer, described as "la plus originale et la plus audacieuse", was the first recorded use of soil nails for temporary slope stabilisation, in this case until a permanent gravity retaining wall was constructed (photograph 6). The soil consisted of cemented Fontainebleau Sand, with 80% of particles 0.1 to 0.4mm in diameter and an angle of friction ranging from 33° to 40°. A "cohesion" of 20kN/m<sup>2</sup> was measured, caused by fines, capillary water and weak cementing.

Cuts were made generally 1.4m high and in 100m lengths but were reduced to 0.7m high where pockets of Marl were found. A 50mm x 50mm steel grillage was fastened to the face before 100mm rotary drilled holes were formed, at a density of two per m<sup>2</sup> (i.e. a vertical and horizontal spacing of 0.7m). The holes were drilled perpendicular to the face, at 20° below the horizontal. Two 10mm bars were grouted into each hole with a neat cement grout (w = 0.8). The face was then formed with 50-80mm of sprayed concrete as a protection against raveling and to bond the various elements of the system together.

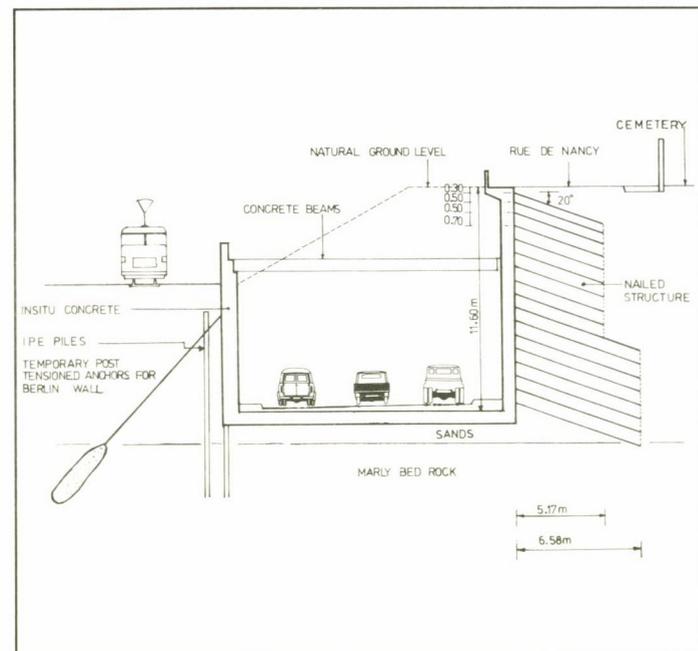
Fig. 20. Cross-section of the Nogent-sur-Marne A86 excavation (After Goulesco and Medio, 1981)

length construction was executed using diaphragm walls in the highly variable sediments. However in one particular zone the proximity of a live railway line to the west and existing structures (including a cemetery) on the east (Fig. 20) demanded the use of alternative methods to form the cut. Here the contractor, a consortium of Bouygues and Chantiers Modernes, proposed the use of an anchored Berlin wall construction for 1 900m<sup>2</sup> (near the railway and where the cemetery prevented nailing being executed), but nailing for the 900m<sup>2</sup> balance where it was possible to drive the reinforcing elements.

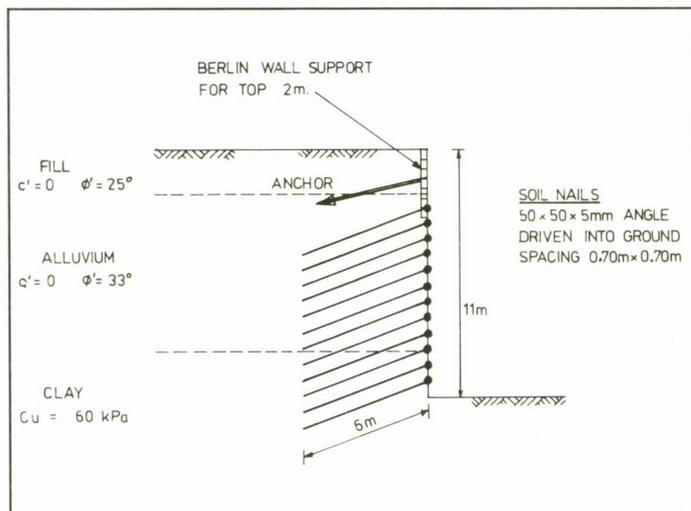
Fig. 19. Cross-section of the Boulevard Victor, Paris excavation (After Medio *et al*, 1983)

Following the success of the soil nailing at Versailles-Chantier, the contractor Bouygues in 1974 executed a small contract involving 1 000m<sup>2</sup> of excavation support up to 12m high, at Les Invalides Metro Station in Paris. This particular contract was noteworthy since it was the first application with driven nails (49mm tubes) as opposed to the drilled and grouted type. Bouygues then applied the principles of this technique in their next application, the stabilisation of the 12 000m<sup>2</sup>, 11m deep excavation for a car park for la Ville de Paris in the Boulevard Victor (Fig. 19). This contract was executed in 1978 and boasted several "firsts"

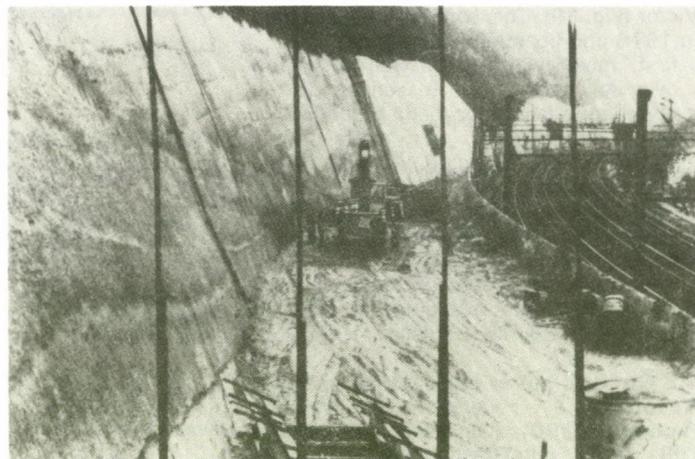
Photo. 6. View showing the nailed excavation and the reinforced concrete wall for permanent support at Versailles-Chantier (Medio *et al*, 1983)

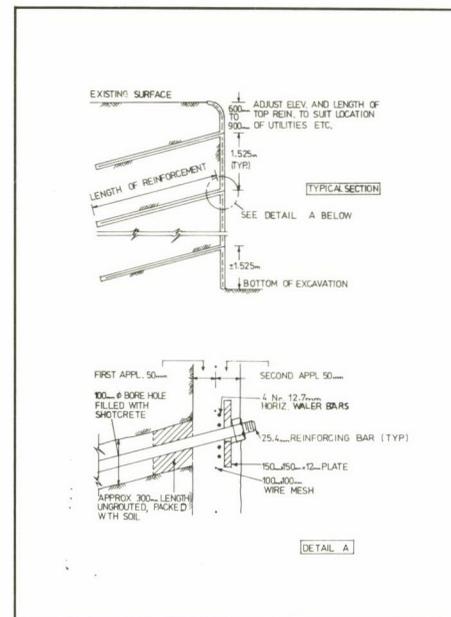
Fig. 21. Details of the soil nailing at the Good Samaritan Hospital site (Shen *et al*, 1981a)

Excavation proceeded in 1.5m cuts, at an average of 100m<sup>2</sup> per day. Mesh was placed 50mm off the face and sprayed with dry mix shotcrete (plus additive) to set in a few minutes and cure in 24 hours. An auger was used to drill the 683 holes 7-8.5m long and at an inclination 15° down. Centralised bars 25 and 38mm in diameter (Fig. 21) were inserted and grouted to within 0.3m of the face, before rows of four 12.7mm rebars were placed to form horizontal wales at each nail level. Following stressing of the bars to 50% to 80% of their design load, (bearing on 150mm square plates), a further 50mm layer of shotcrete was applied. For the lowermost cut, excavation by backhoe or by hand was limited to 6-12m runs, with 6m intervals (excavated and treated afterwards).

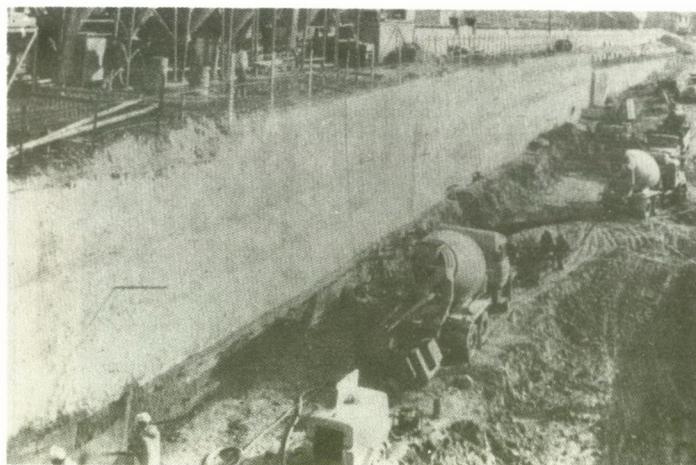
Photo. 7. General view of the Nogent-sur-Marne A86 excavation (Medio *et al*, 1983)

The main wall consisted of driven 50 x 50 x 5mm angles in the upper 9 rows (5.5m long), and 60 x 60 x 6mm angles in the lower eight rows (7m long). Cuts were generally 1.2m high with the nails spaced at two per m<sup>2</sup>. The angle steel reinforcement was bonded to the face mesh and then 50-80mm of sprayed concrete placed (Photograph 7). The main wall was instrumented and showed excellent performance, including:

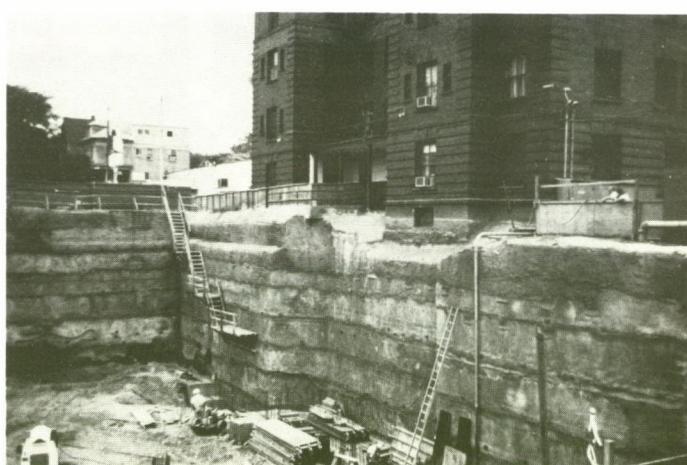
Photo. 8. View of the excavation next to the Marshall Street Annexe at the Good Samaritan Hospital, Portland (Shen *et al*, 1981a)

of 1976 and represents a significant milestone, being the first recorded application of soil nails in the USA. A joint venture of Kulchin and Associates Inc. and Albert K. Leung and Associates contracted to provide 2 140m<sup>2</sup> of nailed wall around three sides of a foundation excavation of maximum depth 13.7m (Photograph 8). The longest wall was 76.3m and up to 11.3m deep.

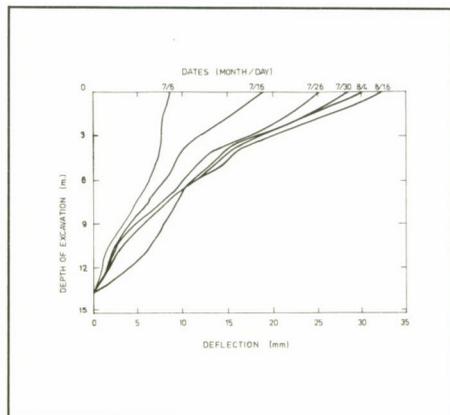
Fig. 22. Horizontal deflections measured on the western boundary wall at the Good Samaritan Hospital excavation (Shene *et al*, 1981a)

Since the system was new and unfamiliar to local engineers and contractors, a limited amount of field instrumentation was installed by research workers from the University of California at Davis. An inclinometer placed halfway along the longest wall and 3m behind the face gave the results of Fig. 22: a measured maximum lateral movement of 33mm (= 0.30% of excavation depth, but later corrected for bottom movement to 0.32%). In addition, a crack survey on foundations of the adjacent Marshall St. Annexe showed tensile cracks of up to 8mm wide as far as 7.6m back from the face. However, it was noted that this building "remained fully occupied and functionable throughout the construction period". (Shen *et al*, 1981a).

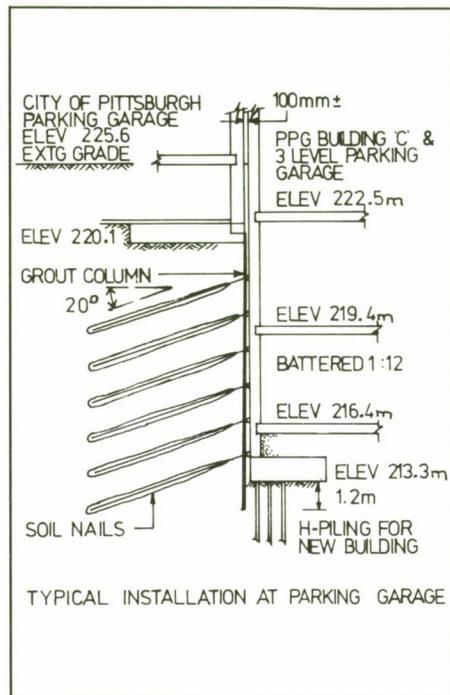
Fig. 23. Cross-section at the PPG Building Parking Garage excavation, showing the face pretreated by grouting (Nicholson and Wycliffe-Jones, 1984)

The soil nailing technique was amended and adapted to local conditions and requirements as the work proceeded. In some areas, vibrations from the Main Contractor's excavation equipment induced local failures in the cohesionless granular soils. Local stability for the face of the soil nailing excavations was therefore improved by drilling fully cased holes of 127mm dia at 250-300mm centres along the line of the foundations. These holes were inclined at about 8° from the vertical to avoid interference with the new structure, were taken to 1.2m below final excavation level, and pressure grouted after the insertion of a steel reinforcing bar. Excavation in 1m cuts showed the grout penetration to be sufficient to prevent further ravelling or sloughing of the face. The installation of the nails then proceeded in the standard fashion (Fig. 23).

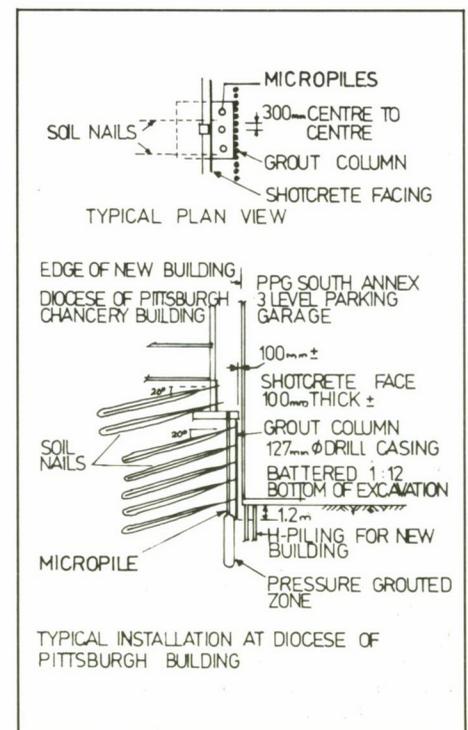
Fig. 24. Excavation adjacent to the Diocese Building showing direct underpinning through the nailed zone to minimise settlement (Nicholson and Wycliffe-Jones, 1984)

movement. Groups of vertical 450kN mini-piles were installed to support about half of the total vertical load of the foundation directly, before the excavation proceeded (Fig. 24).

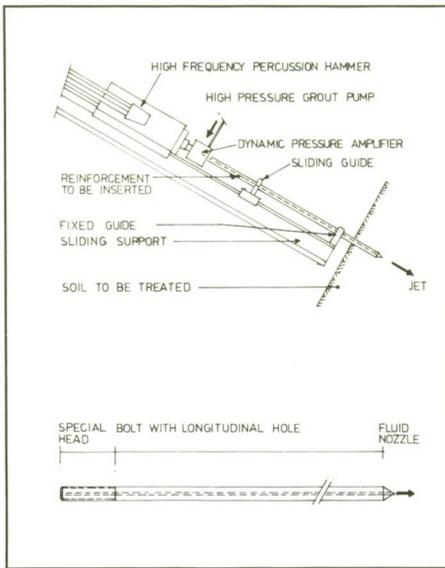
Fig. 25. The "Jet Bolting" technique for soil nail installation which combines vibro-percussion and high grout pressure at the nail tip (Louis, 1984)

Most recently Louis (1984, 1986) has reported patented\* systems of nail installation for which very high rates of production are claimed. In the "Jet Bolting" system (Fig. 25) very high pressures, over 200bar, are used to inject cement grout through small apertures at the tip of the nail whilst it is being installed or percussed into the soil. This jet grout lubricates the penetration of the nail, and upon setting is claimed to provide an enhanced bond capacity for the nail. An improvement of the performance of loose sand or soft clay between nail locations is also claimed, but is as yet unquantified. Jet bolting systems have not yet had significant commercial application outside Southern France, to the authors' knowledge.

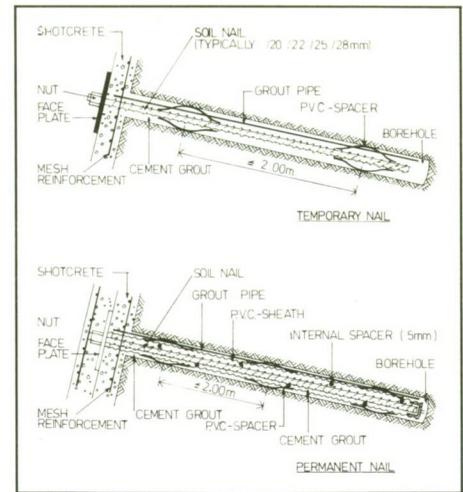
Fig. 26. Examples of good practice for drilled and grouted nail installation (a) for temporary applications and (b) for permanent applications (Based on West German experience, reproduced with permission of Bauer, AG)

For temporary applications in standard environments, corrosion protection is usually provided only by the grout, and sometimes with an epoxy coating to the steel surface (Fig. 26a). For permanent works, the degree of protection may be increased by providing

an outer sheath of plastic material, ensuring an inner annulus of at least 5mm thickness (Fig. 26b). Other proprietary systems have also been developed to overcome the potential problems arising from microfissuring of the grout under tension (e.g. the "Intrapac" nail of Intrafor-Cofor). In all cases, centralisers are placed at regular intervals (say 2m) along the reinforcement to ensure concentricity with the borehole.

One of the most recent studies on corrosion in reinforced earth (FHA, 1985) has demonstrated once more that the understanding of corrosion mechanisms for metals is incomplete and that long-term problems can occur. This would suggest that good practice for permanent soil nailing installations should require direct protection by at least one sheathing along the lines developed, and codified, for ground anchorages. This type of permanent nail installation is illustrated in Figure 26b.
